COLLEGE BUILDING SOUTH & VICINITY BUILDINGS ASSESSMENT

October 27, 2021

INTRODUCTION

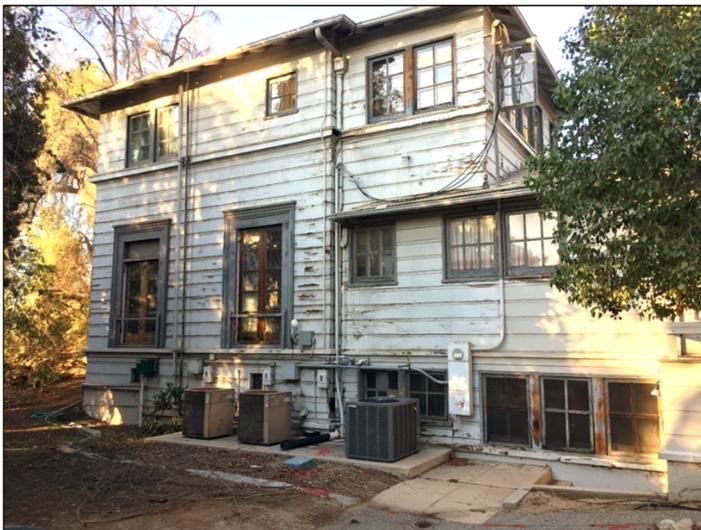
COLLEGE BUILDING SOUTH (built 1916)

College Building South is in serious disrepair with significant deferred maintenance needs. In response to the UC Seismic Safety Policy update of May 2017, UCR completed its first phase of seismic building assessments in early 2019. College Building South was assessed by an independent structural engineering consultant and rated as a “VI” on a scale of “I” (best anticipated performance in a major seismic event) to “VII” (anticipated to be very unsafe in a major seismic event).

Per UC Seismic Safety Policy, a seismic rating of VI requires the building to be retrofitted or vacated by 2030. Furthermore, an immediate reduced-use plan is needed in the interim.

Required seismic repairs, along with comprehensive deferred maintenance improvements, hazardous materials abatement, and code and life safety upgrades are estimated to be approximately \$5.8M.²

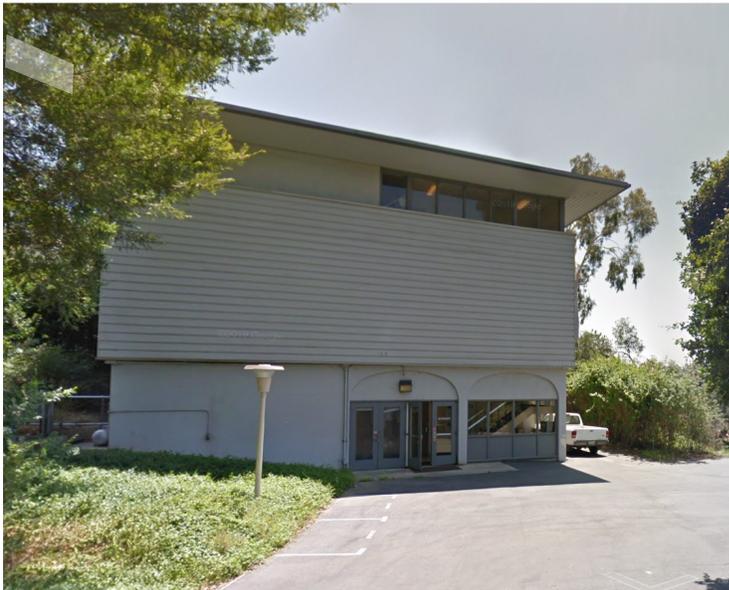
COLLEGE BUILDING NORTH (built 1963)

In response to the UC Seismic Safety Policy update of May 2017, UCR completed its first phase of seismic building assessments in early 2019. College Building North was assessed by an independent structural engineering consultant and rated as a “V” on a scale of “I” (best anticipated performance in a major seismic event) to “VII” (anticipated to be very unsafe in a major seismic event).

Per UC Seismic Safety Policy, a seismic rating of V requires the building to be retrofitted or vacated by 2030.

Required seismic repairs, along with comprehensive deferred maintenance improvements, hazardous materials abatement, and code and life safety upgrades are estimated to be approximately \$5.9M.³

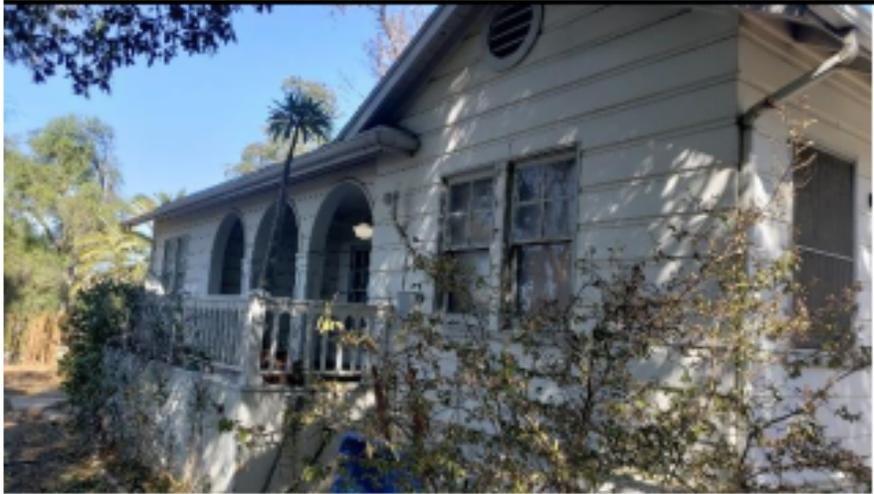
SUPERINTENDENT’S COTTAGE (built 1916) & Ancillary Structures

In response to the UC Seismic Safety Policy update of May 2017, the UCR campus completed its first phase of seismic building assessments in early 2019. The Superintendent’s Cottage was assessed by an independent structural engineering consultant and rated as a “V” (best anticipated performance in a major seismic event) to “VII” (anticipated to be very unsafe in a major seismic event). Seismic repairs estimated at \$107,000 per Campus Seismic Plan, April 30, 2021

Per UC Seismic Safety Policy, a Seismic Rating of V requires that the deficiency be corrected or the building vacated by 2030. Required seismic repairs, along with comprehensive deferred maintenance improvements, hazardous materials abatement, and code and life safety upgrades are estimated to be approximately \$1.0M.⁴
